Planning Study for the

MONTGOMERY COUNTY Courthouse

Crawfordsville, Indiana

March 14, 2022

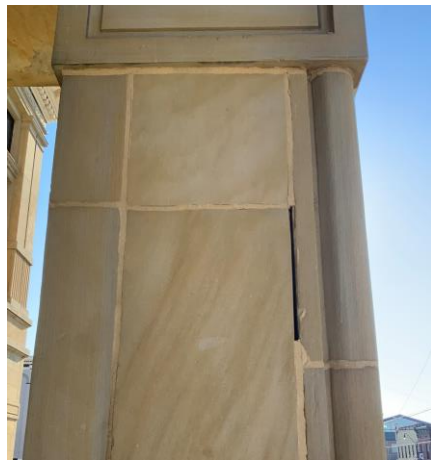
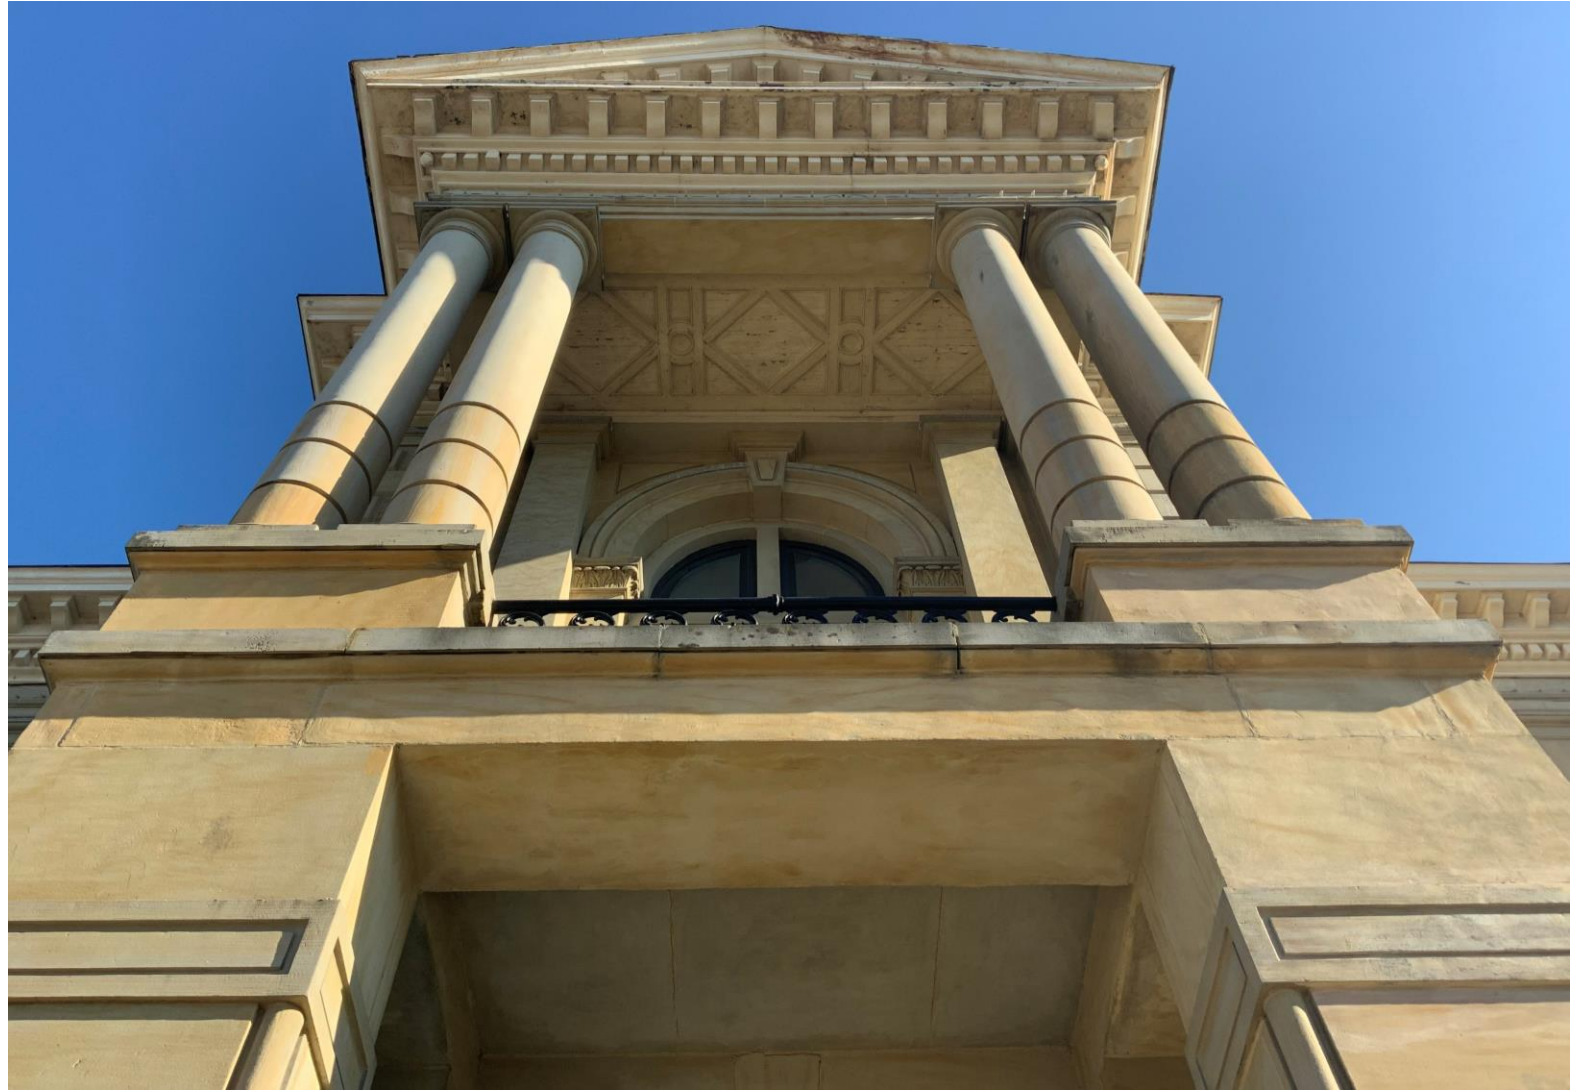
WEST ENTRANCE

- Entablature needs rehabilitation / restoration
- Stone head joints need tuckpointing
- Soffit needs patched and repaired
- Replace sealants
- Clean stone

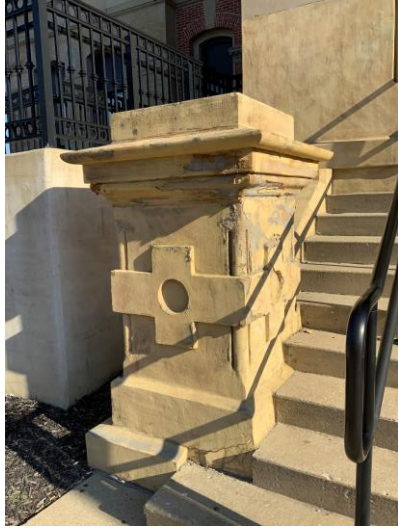
West entrance columns
need patched and repaired
Handrails need painted

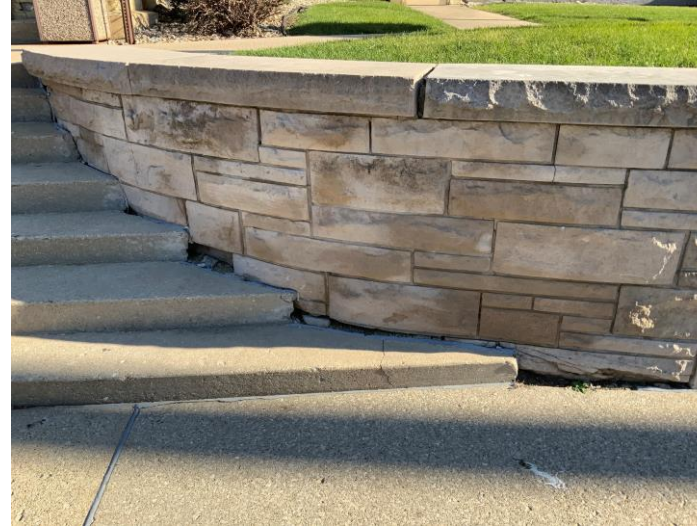
Low stone wall at west
entrance needs tuckpointing
and sealant at head joints –
some stone pieces have
deteriorated and should be
replaced

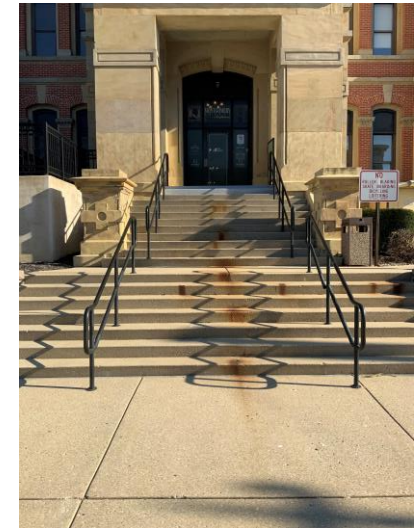
West entrance concrete
stair is stained from
where previous handrails
were removed

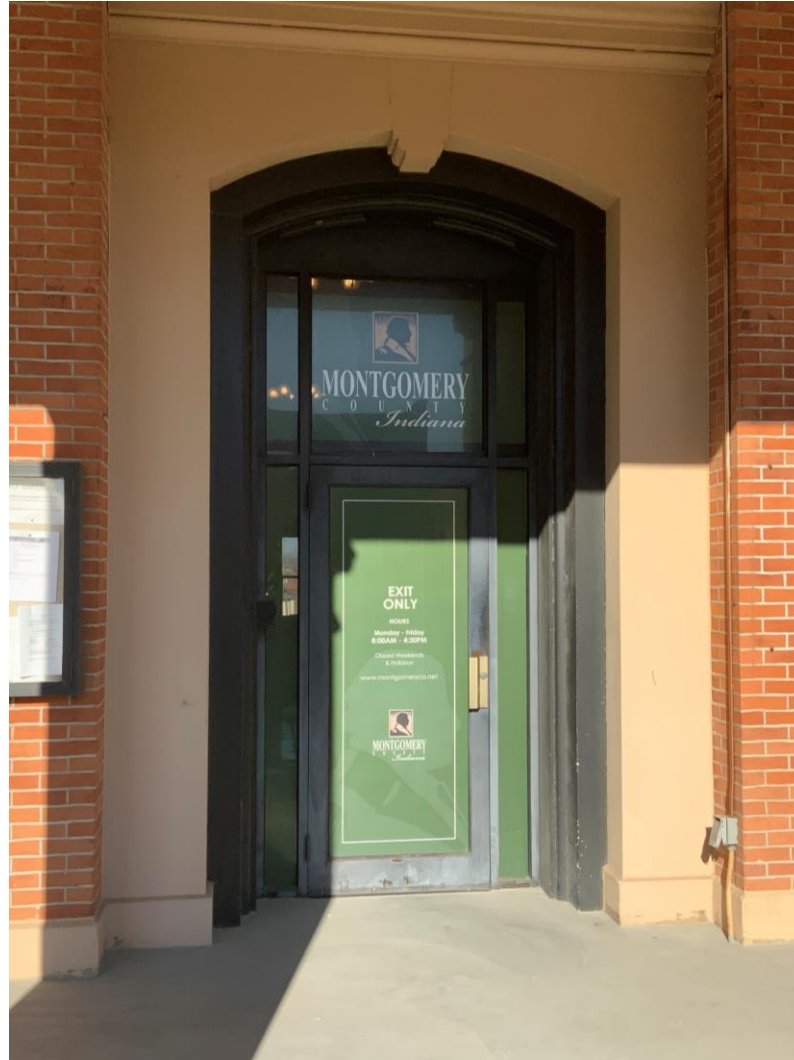
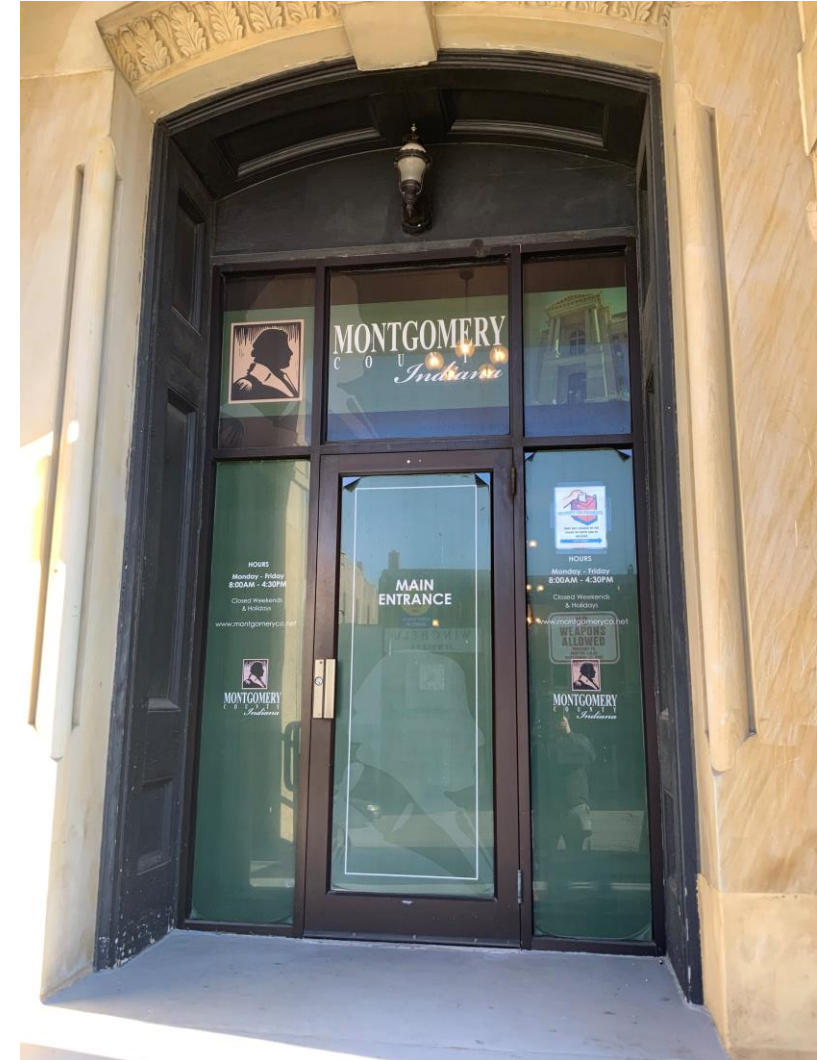
ENTRY DOORS

- Replace exterior aluminum entry door system and signage/graphics
- Clean adjacent materials
- Paint surrounding wood
- Sealants need replaced
- Upon replacement, provide vintage appropriate style door system

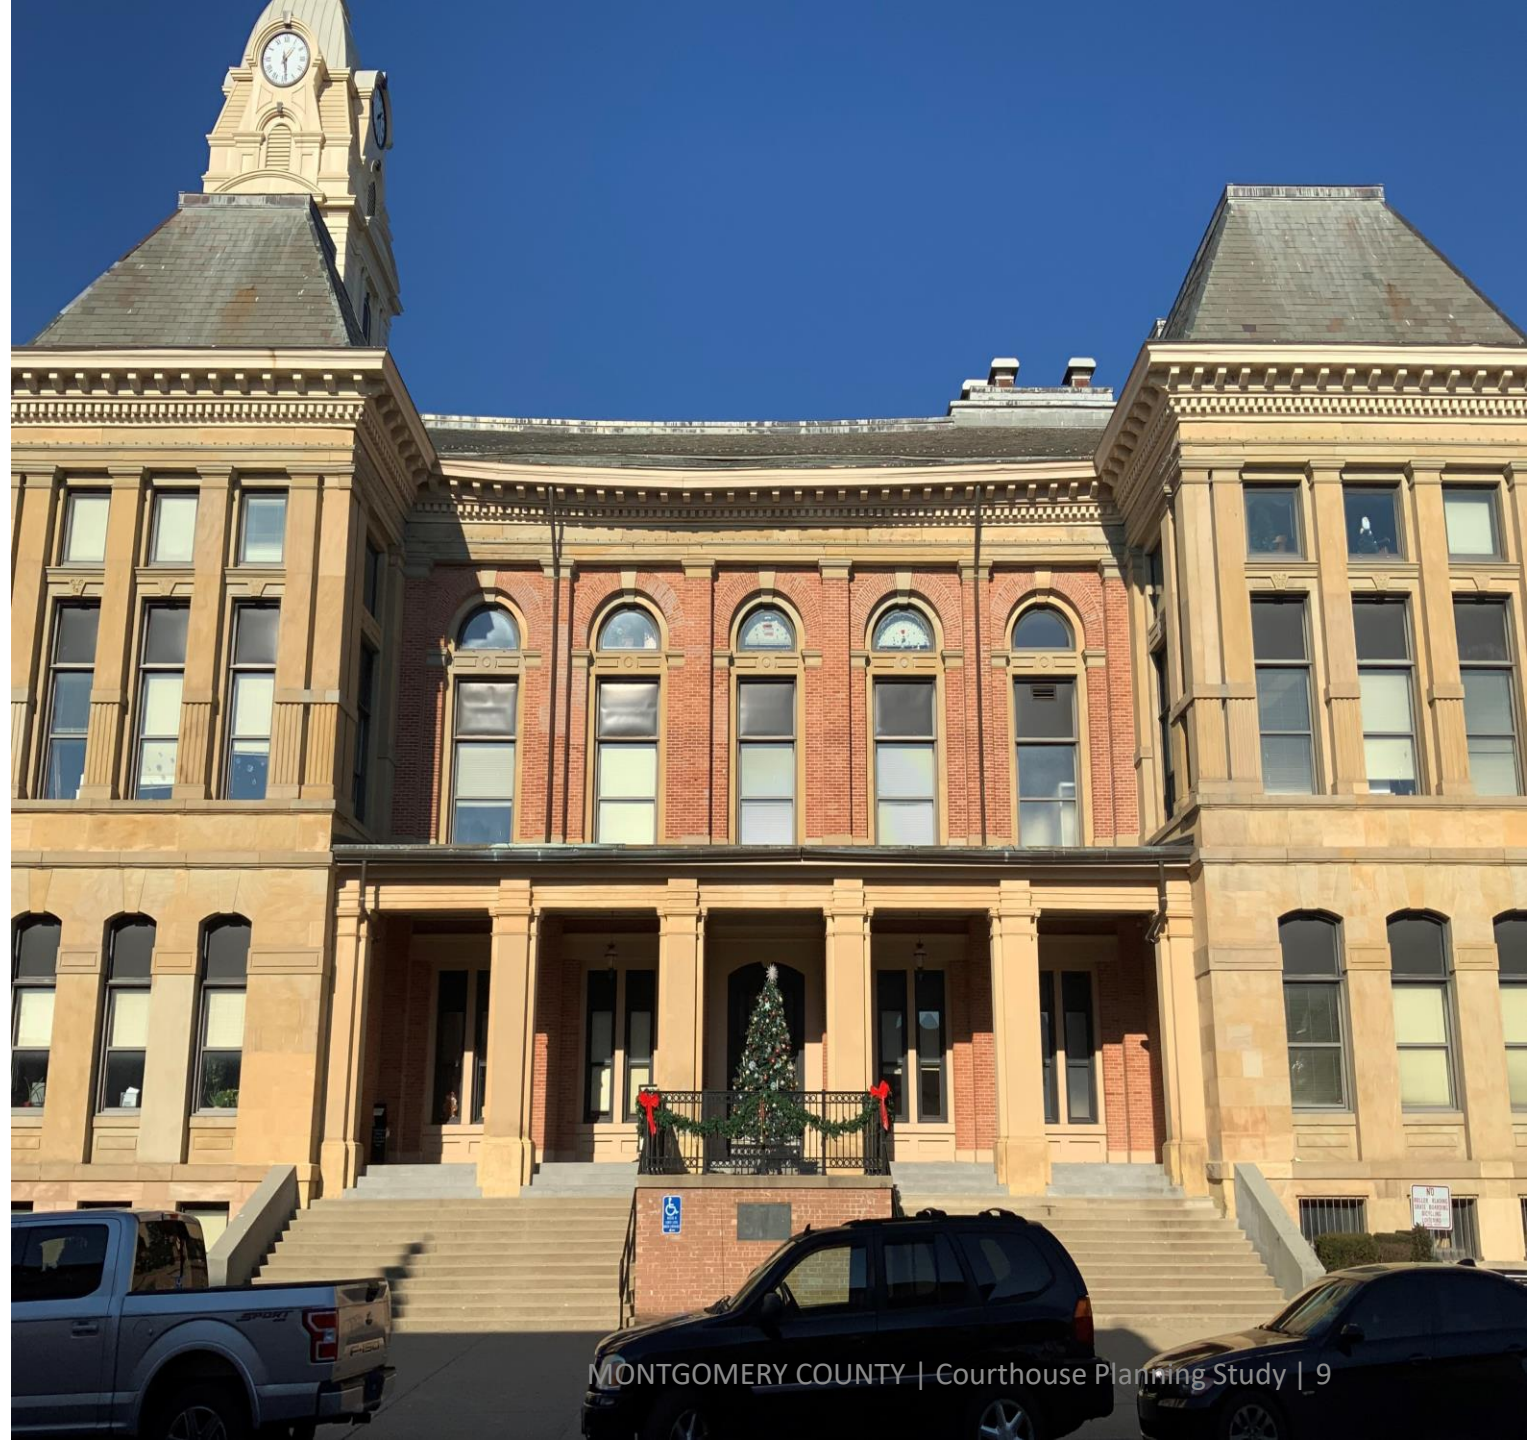
SOUTH ELEVATION

- Entablature needs rehabilitation / restoration
- Stone head joints need tuckpointing
- Soffit at exit needs patched and repaired
- Sealants need replaced
- Clean stone
- Window replacement with vintage appropriate style
- Eave/gutter line is failing - need to conduct a structural analysis

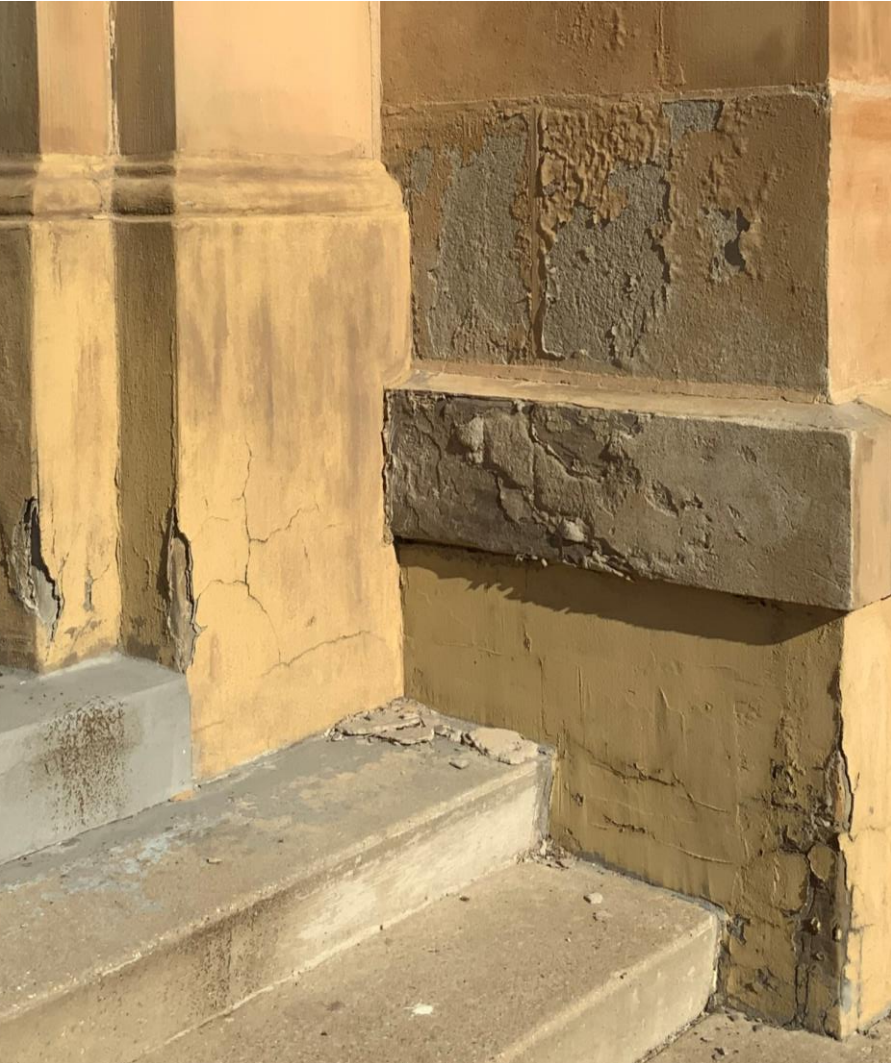
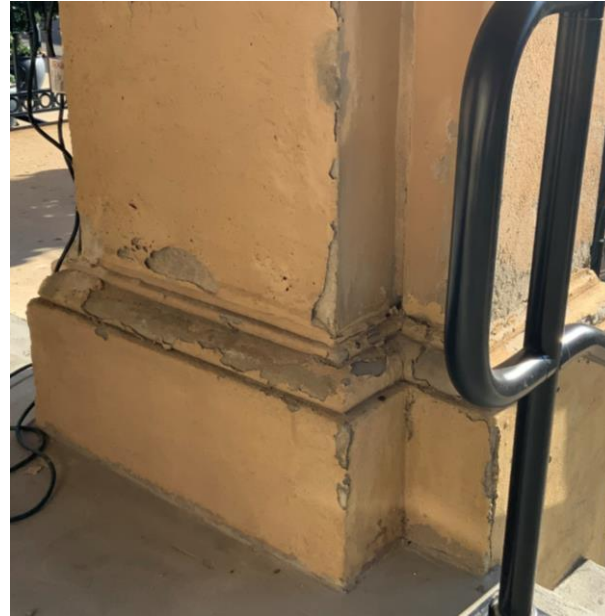
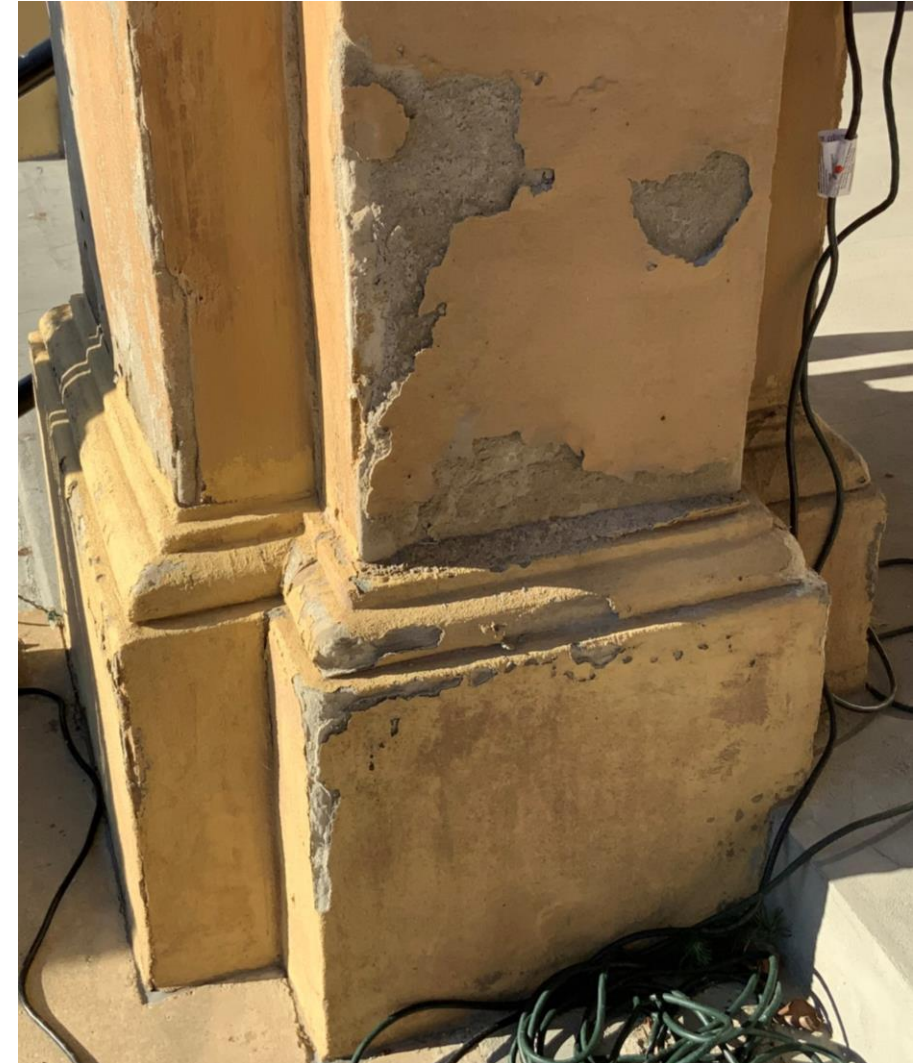
Skim layer over stone is failing and needs replaced
Typical of many locations

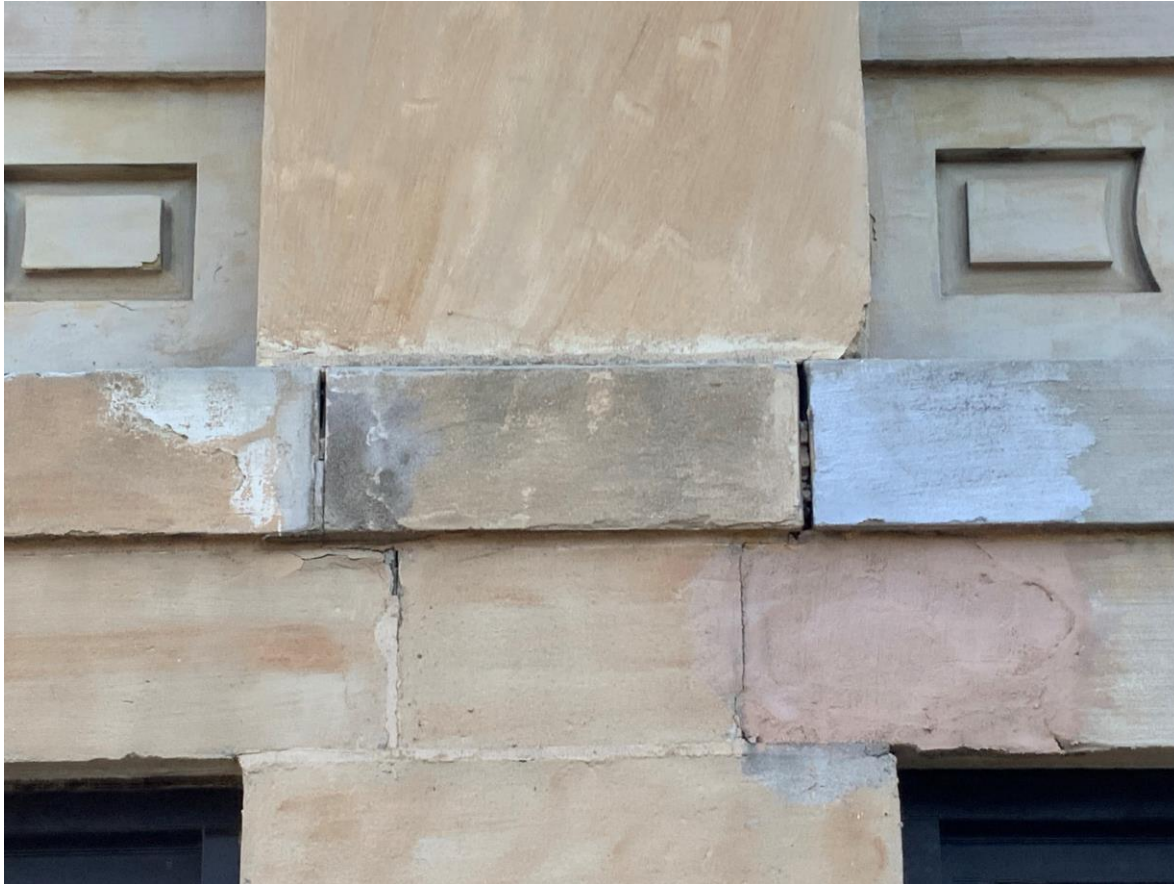
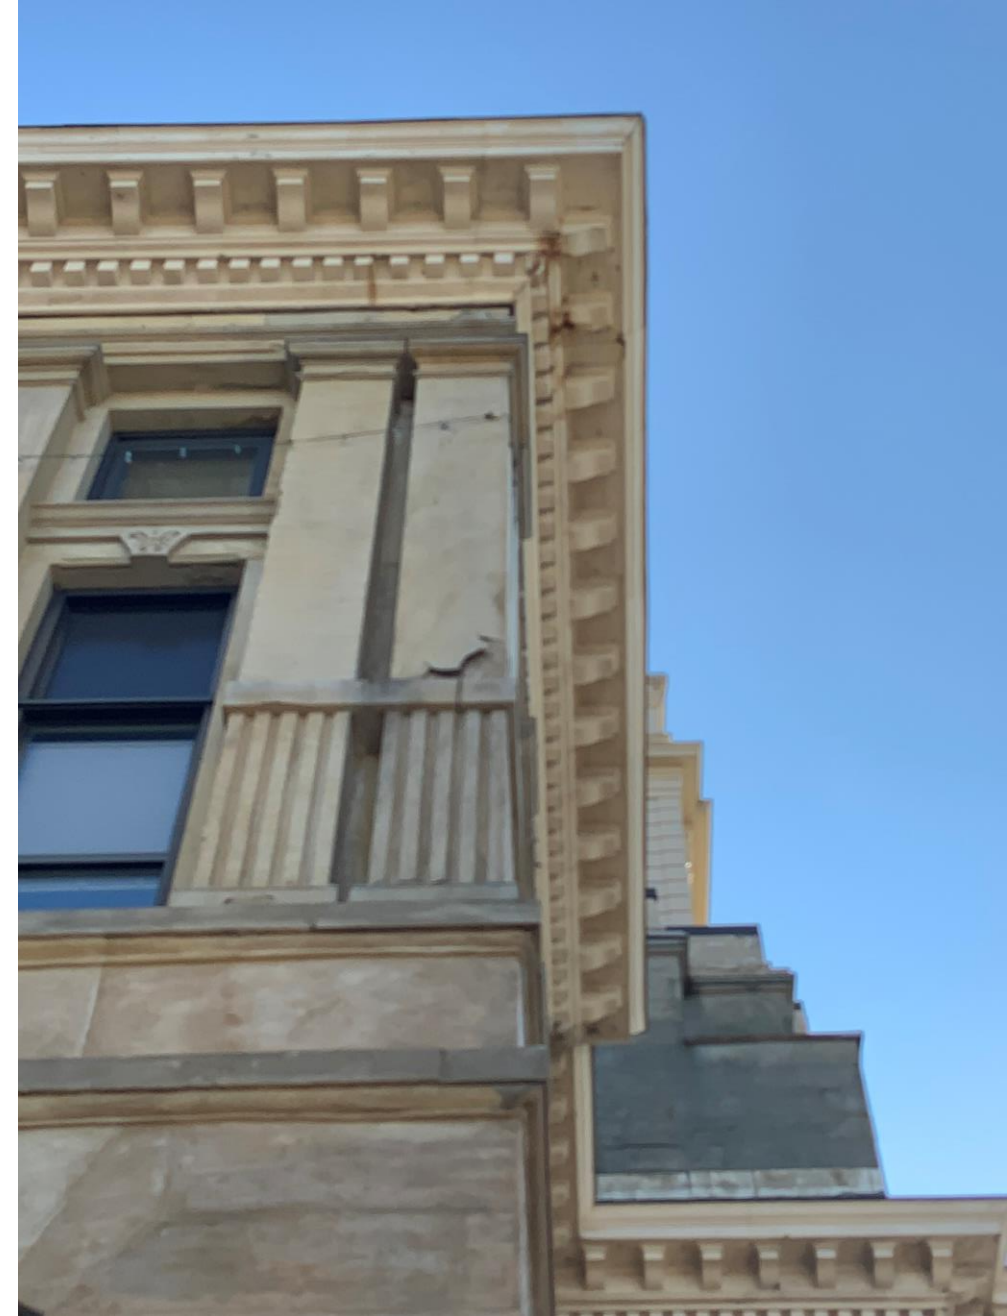
- Sealants need replaced
- Patch and repair stone

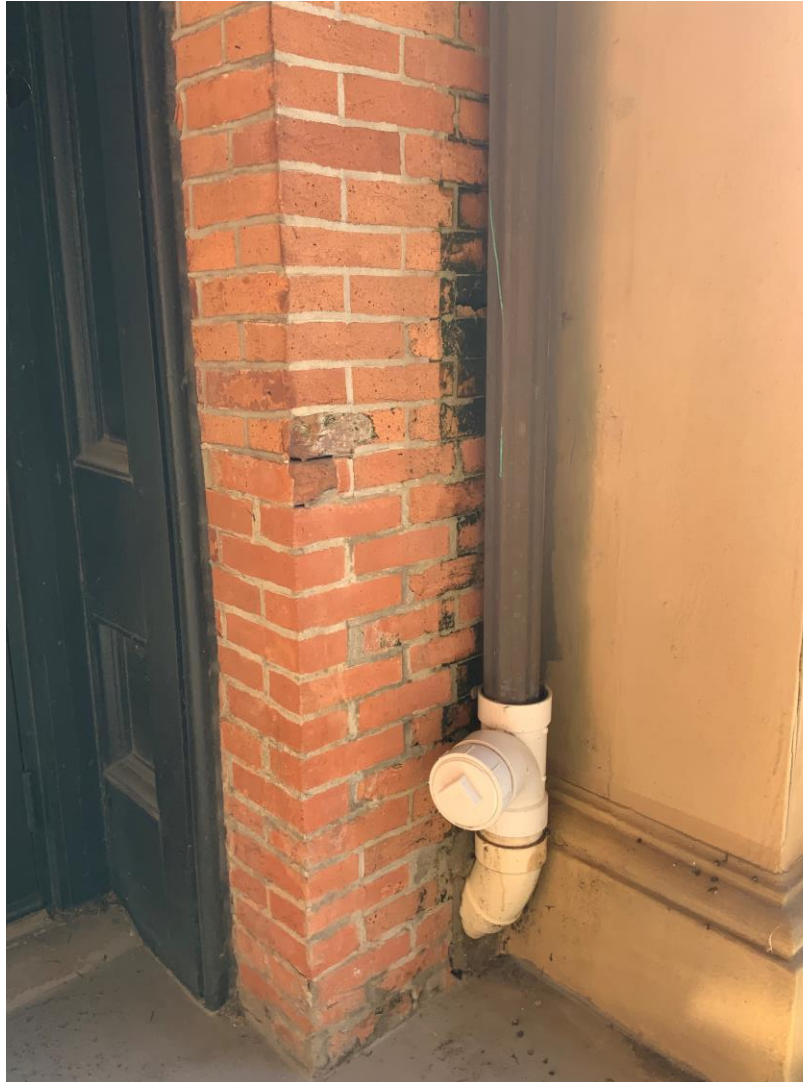
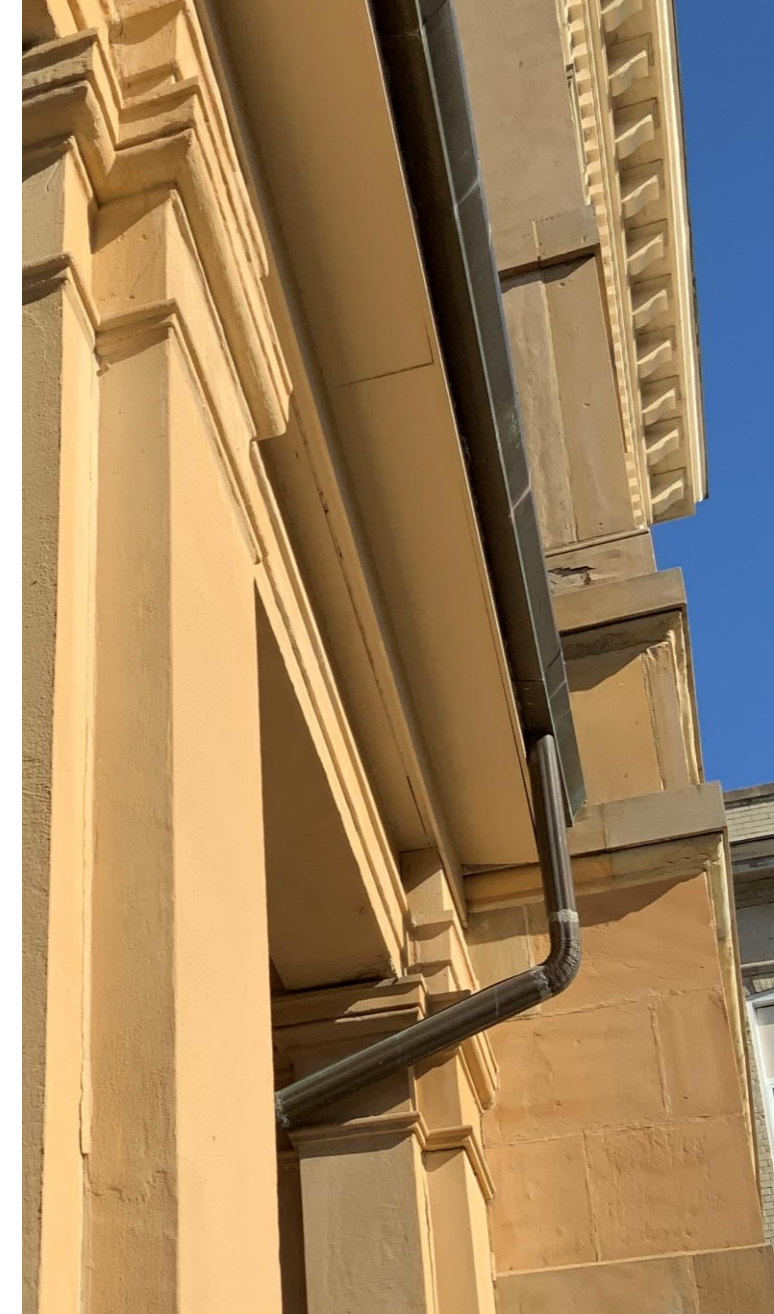
DOWNSPOUT

- Over time, the downspout has leaked causing severe water damage
- Replace spalled brick
- Clean and tuckpoint brick / stone
- Sealants need replaced
- Patch and repair floor
- Re-routing the downspout to stay on the outside of the 'porch' would be more appropriate

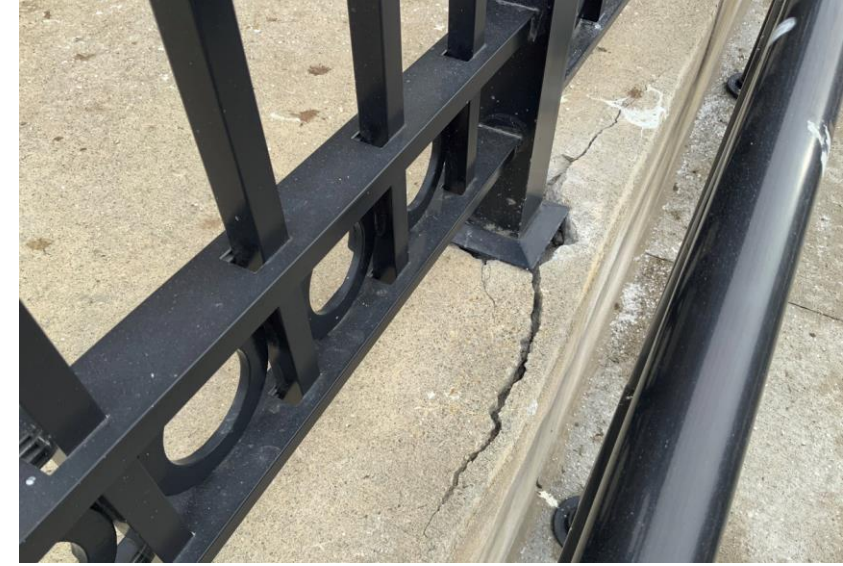
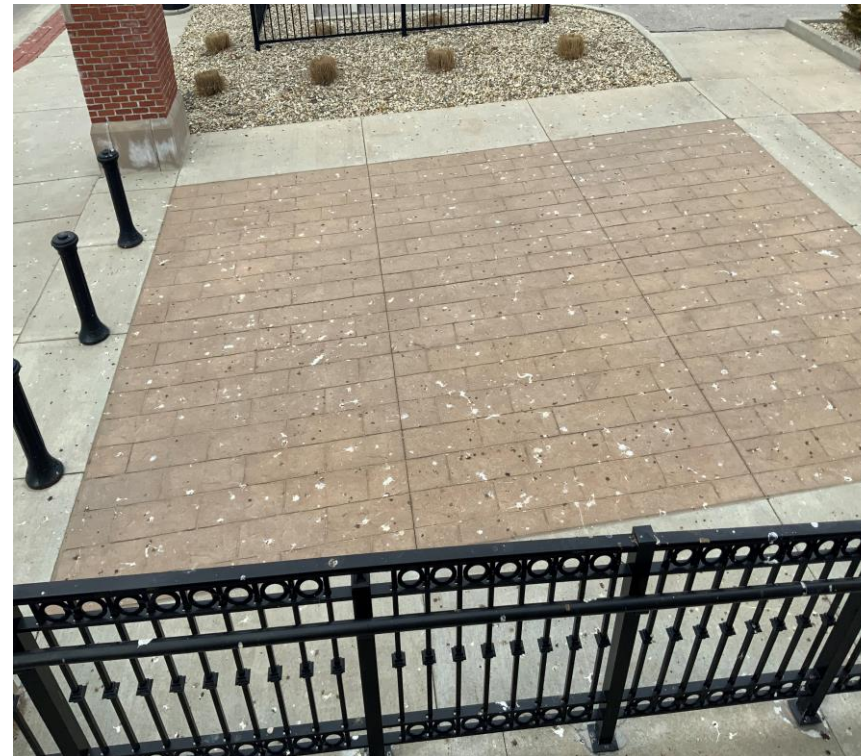
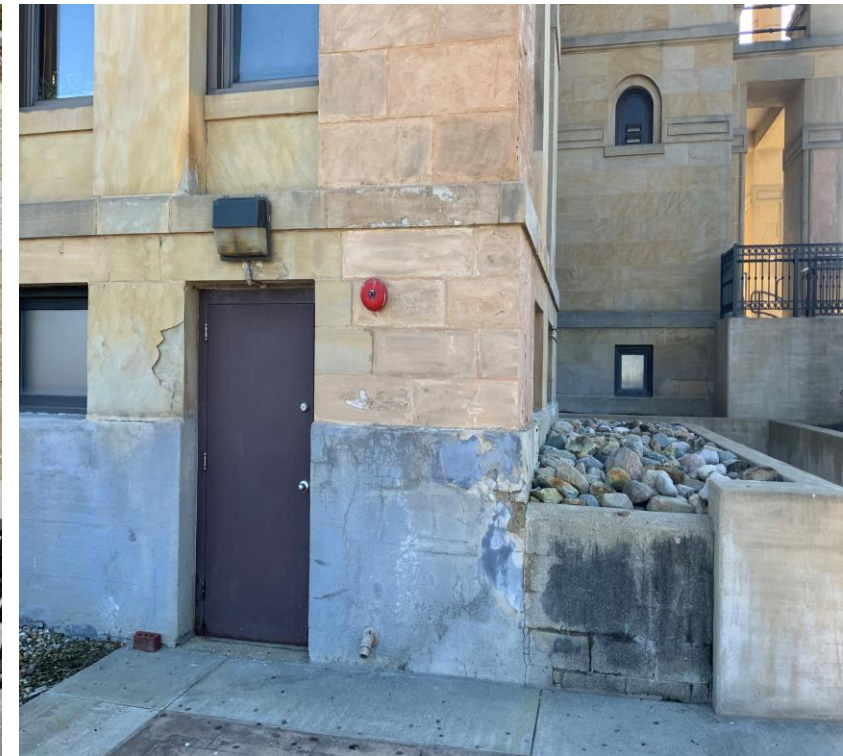
NORTHWEST

- On the ramp, there are several concrete cracks at the vertical posts
- On the roof and the ground surrounding the Courthouse, there is a significant bird issue
- Paint doors and frames
- Mitigate water infiltration
- Patch and repair stone

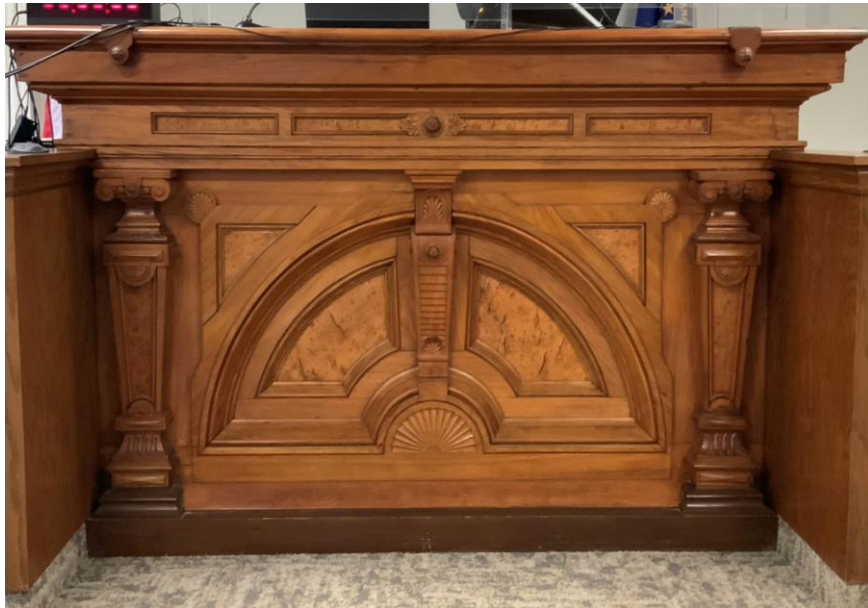
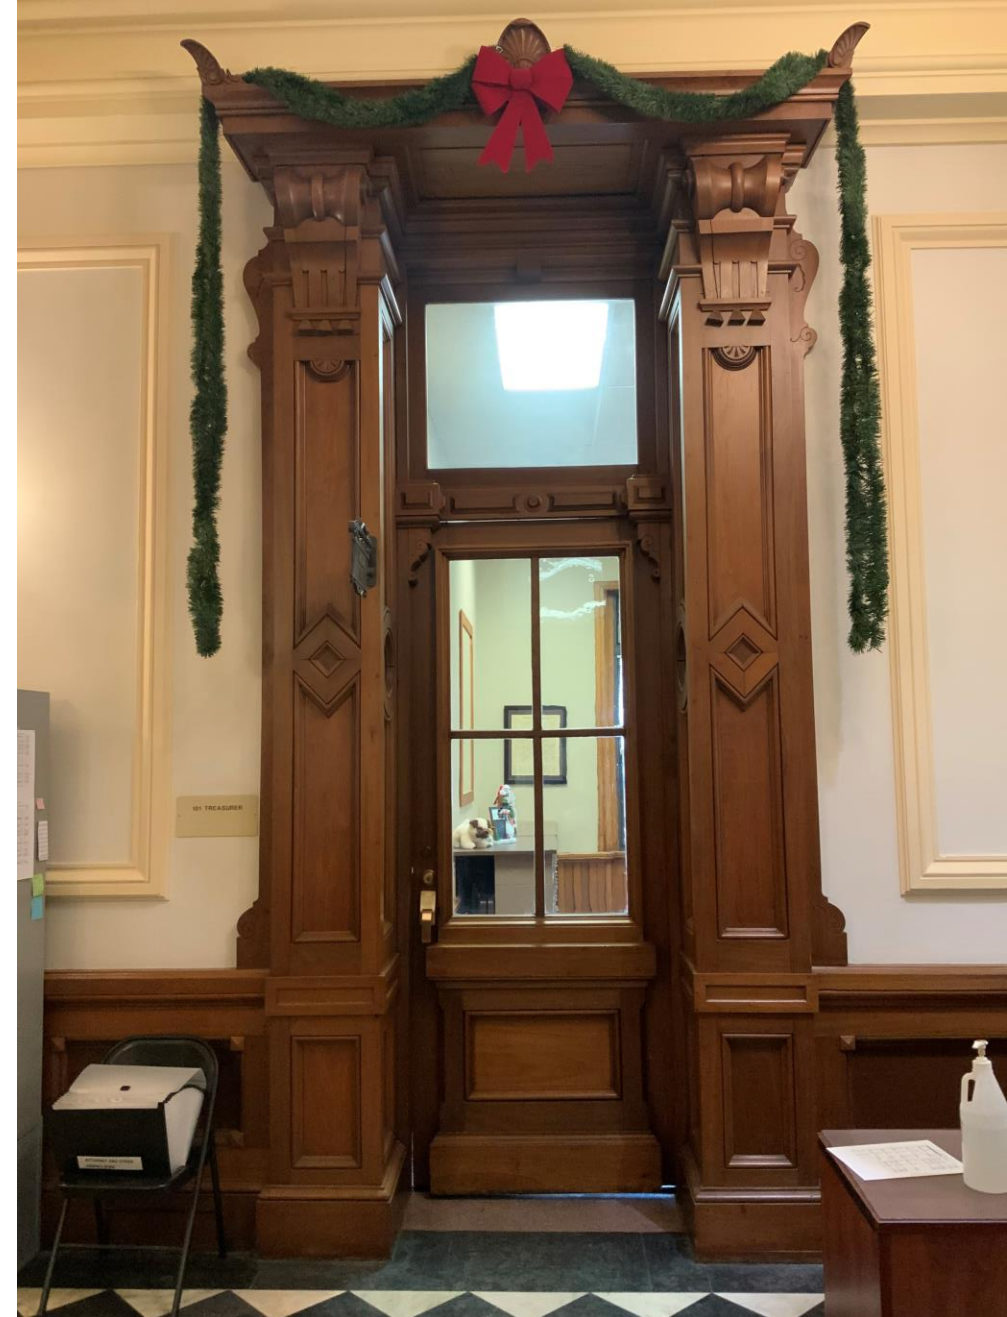
- Any renovation or repurpose of spaces needs to maintain the integrity of the historic Courthouse
- Historic materials needs to be salvaged if scope of work requires removal
- Address general finishes, MPE and IT issues in areas being repurposed / renovated
- Key Fobs on Doors
- Remove Holding Cell carpet

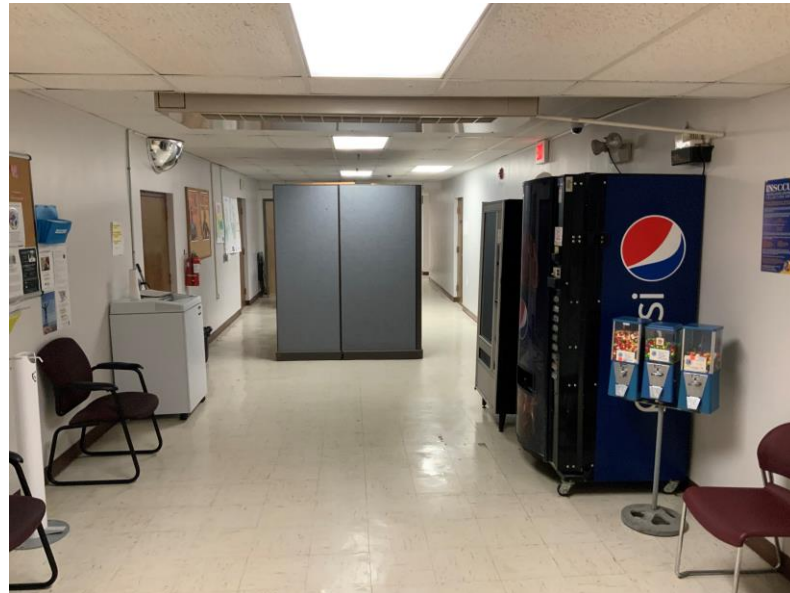
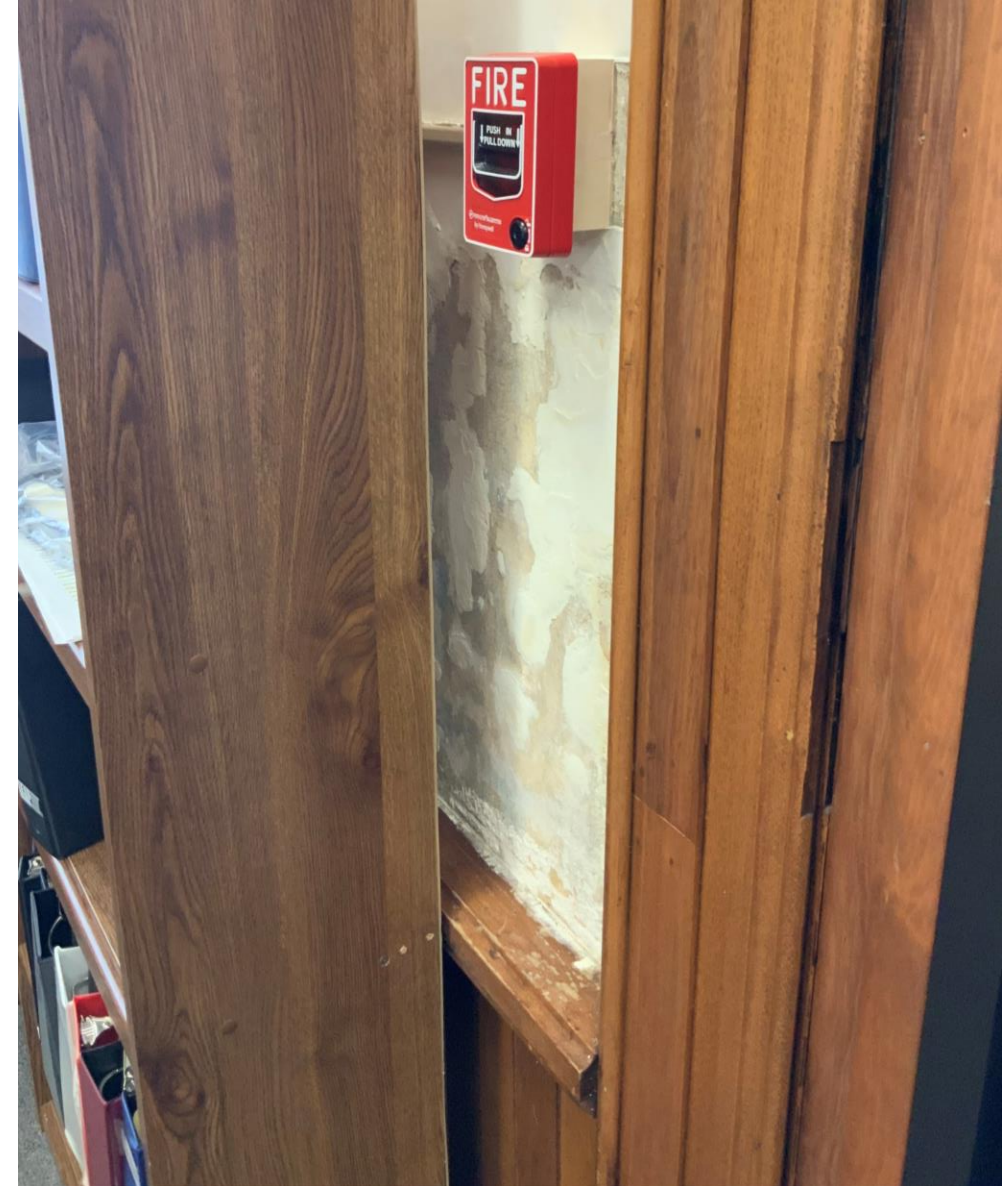
- Mitigate water infiltration
- Patch and repair damaged areas
- Additional room signage and wayfinding signage
- ADA upgrades per prior Study
- Renovate Lower Level
 - Repurpose area
 - Efficient Storage System

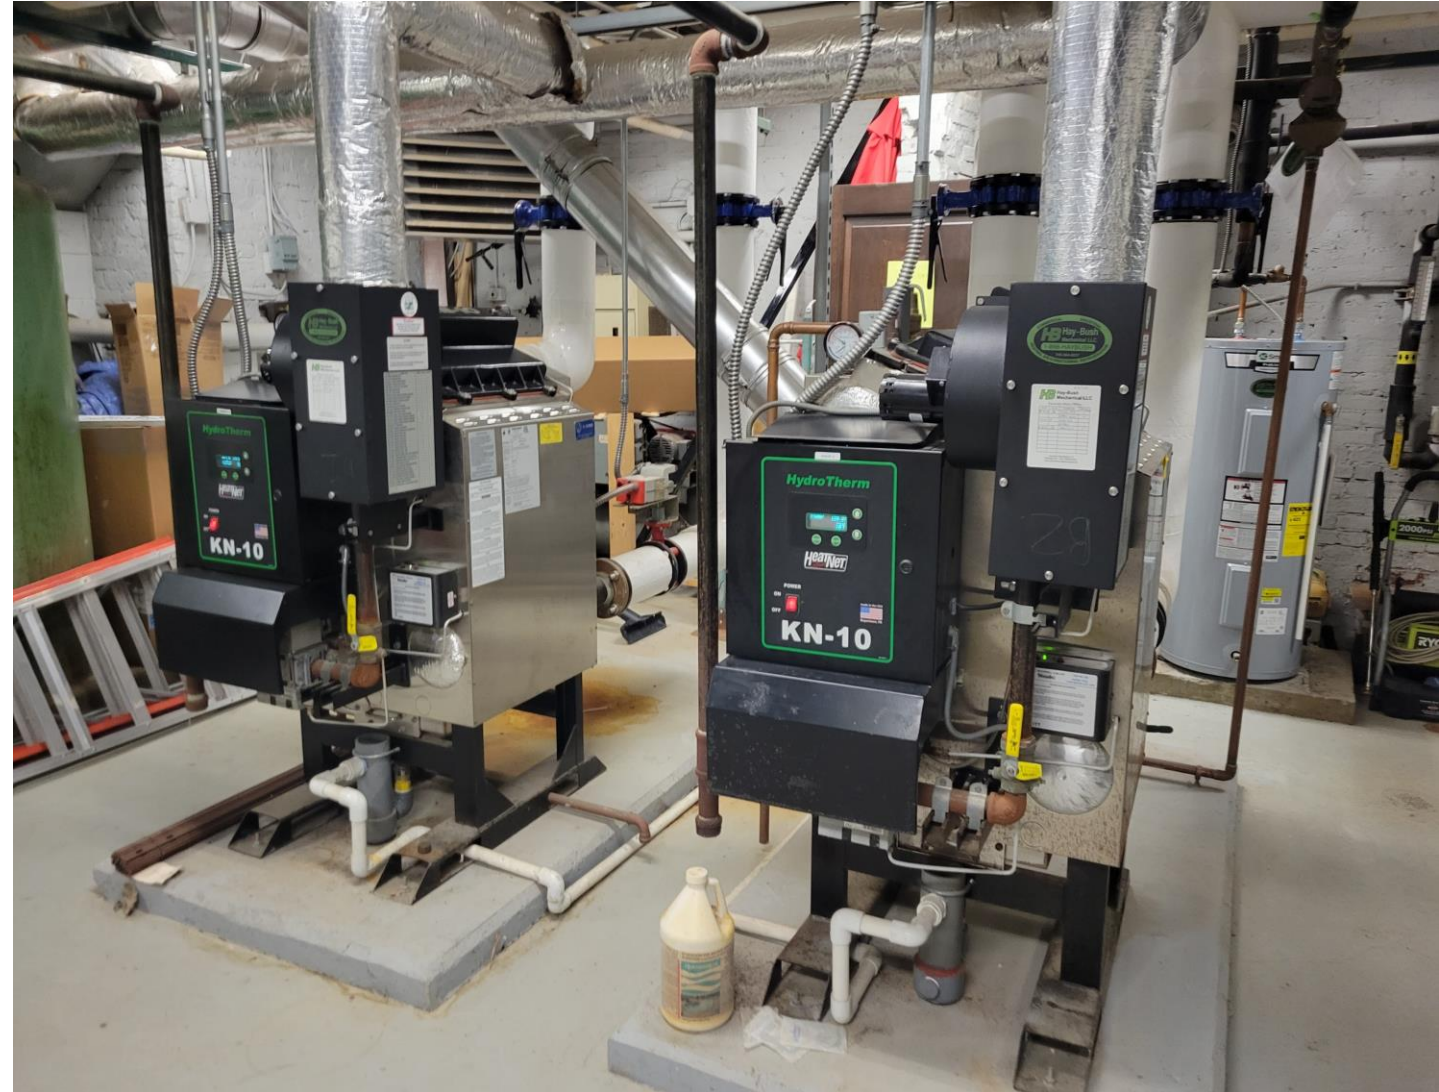
- Major HVAC equipment replaced around 2010-2011
- Boilers in fair condition, no known issues
- Chillers in fair condition, no known issues
 - Remote evaporator, outdoor air-cooled condensing unit
 - Refrigerant monitor & exhaust in mechanical room
- HVAC Pumps in fair condition
- Facility maintains chemical treatment on HVAC water systems

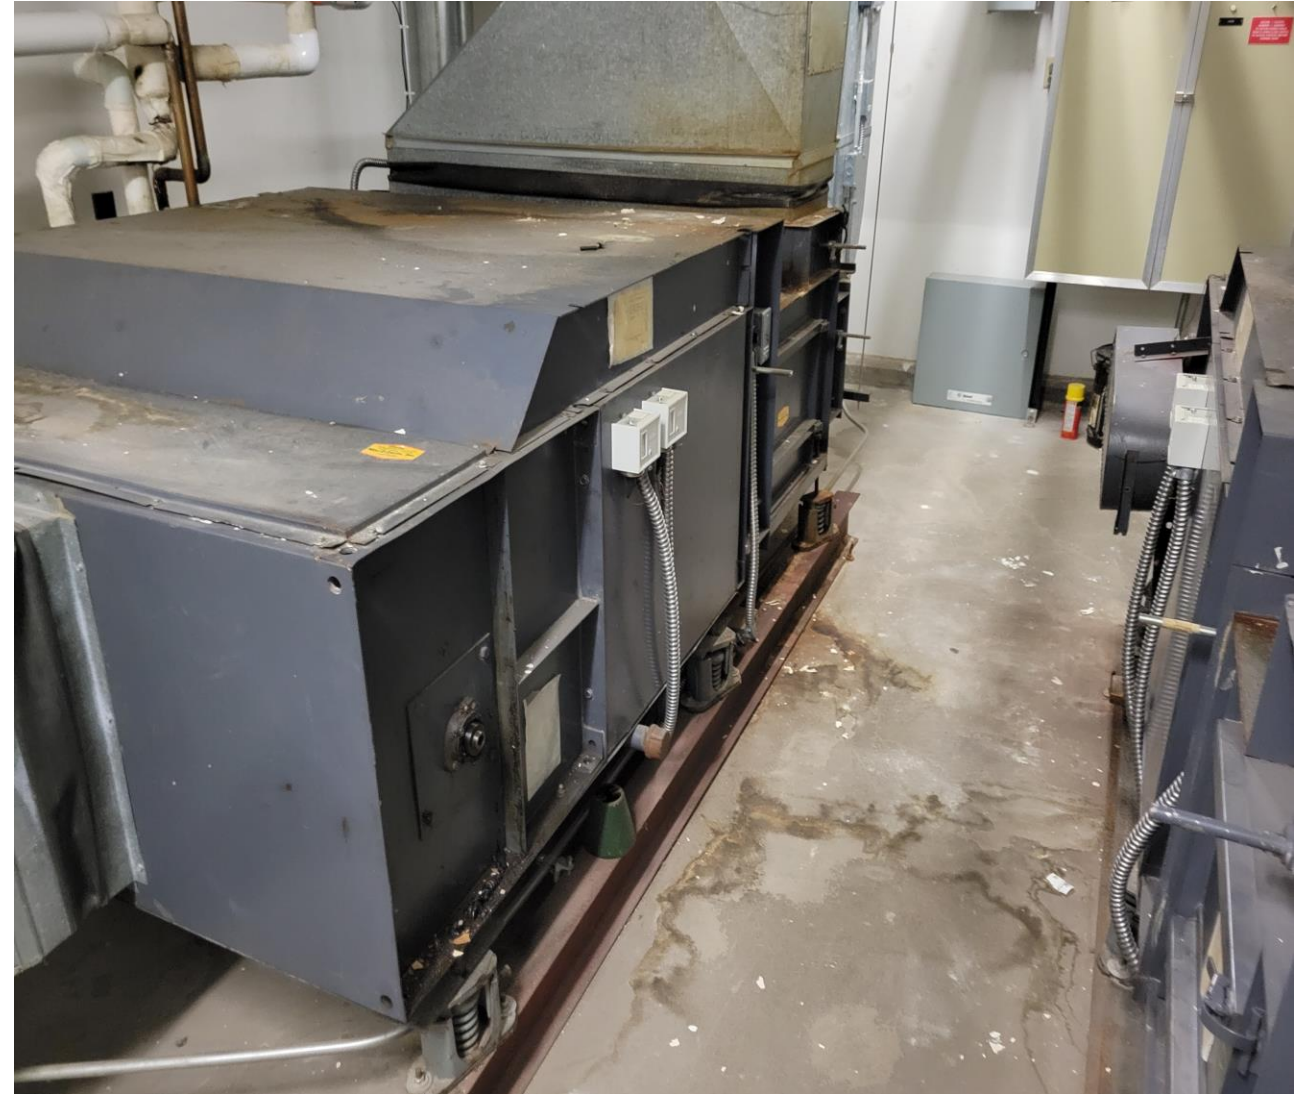
- HVAC Direct Digital Controls installed approximately 10 years ago
- Console-type four-pipe Fan Coil Units (FCU) serve most spaces
 - No known issues with units
 - Some have issues with control valves
- Areas served by FCUs do not have outside ventilation air
 - Renovated Areas may require ventilation air
- Lower Level Storage concern with humidity issue
- Courtrooms are served by modular, forced air units
 - Units in fair condition, no known issues
