Planning Study for the

MONTGOMERY COUNTY Courthouse

Crawfordsville, Indiana

March 14, 2022

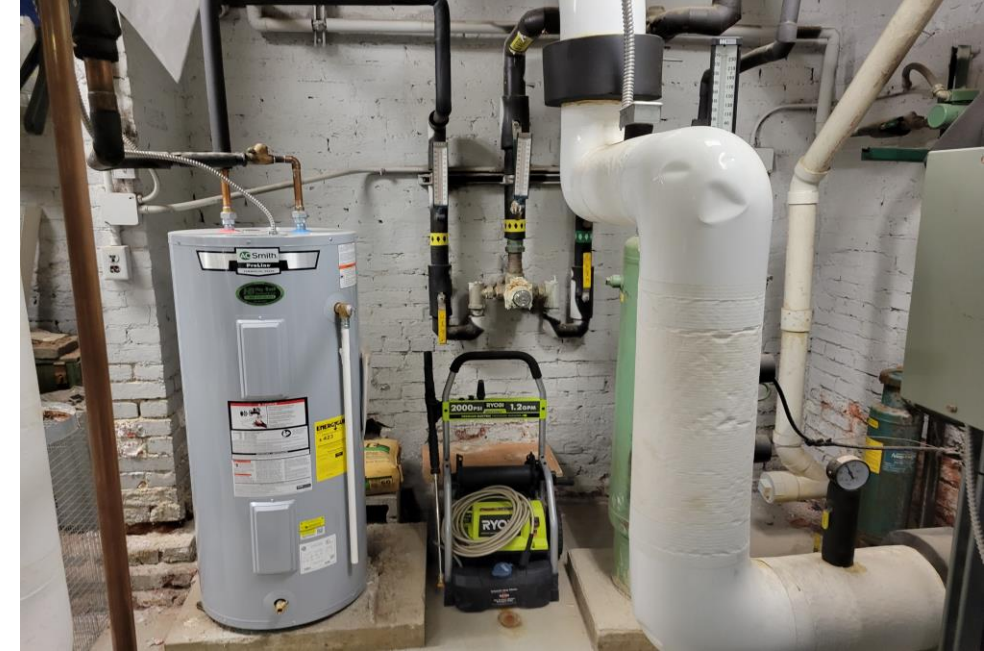
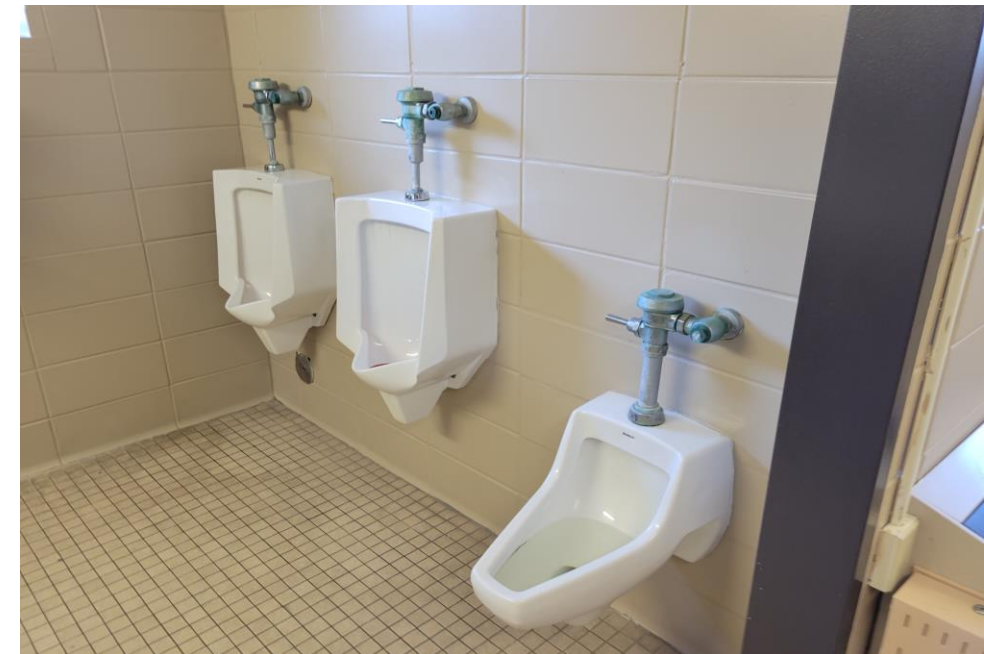
- Electric Domestic Water Heater in good condition
- Hot water return pump in fair condition
- Thermostatic Mixing valves shows signs of corrosion and should be replaced
- Plumbing fixtures in restrooms are old
 - Recommend replacing faucets/flush valves at a minimum
- Replace single height water cooler with dual height, ADA compliant unit
- Building does not have a water softener
- No reported issues with water or sanitary piping

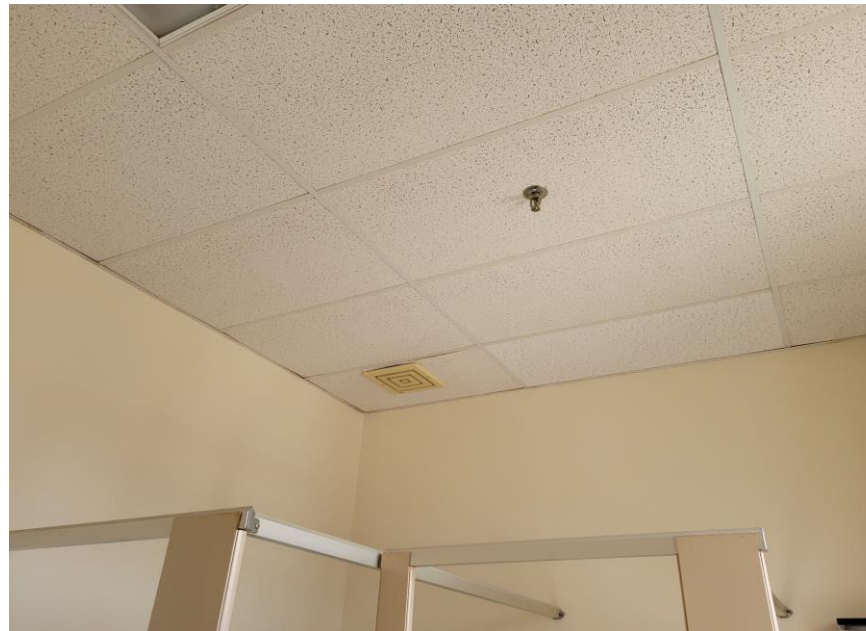
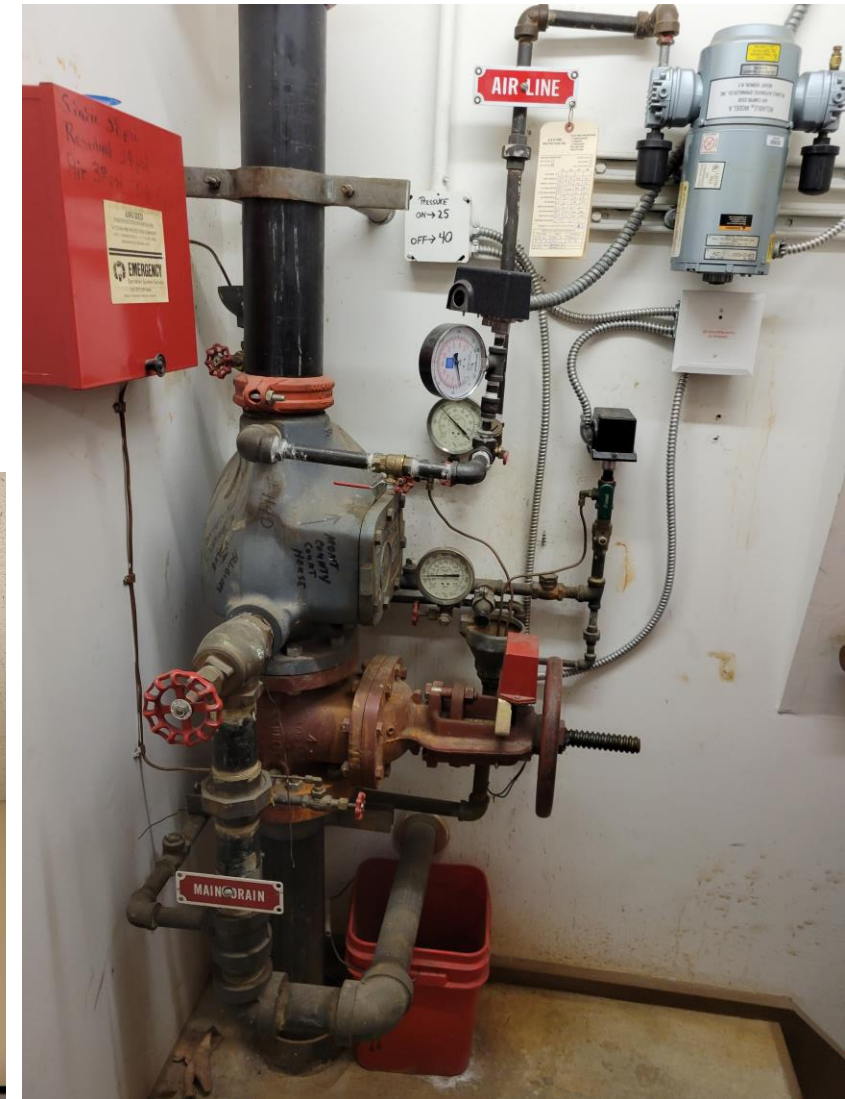
- Building is fully sprinklered
- Office and courtroom areas served by a wet-pipe system
- Attic served by a dry pipe system
- Building does not have a fire pump
- No reported issues with the existing system
- Lower Level Storage concern with wet pipe sprinkler system
 - Could damage records

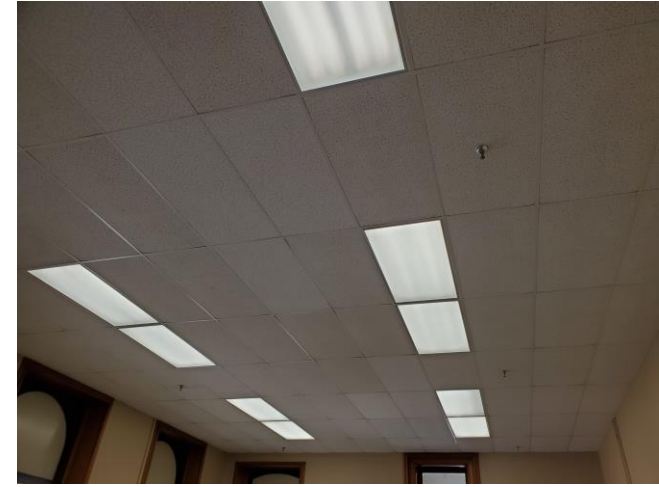
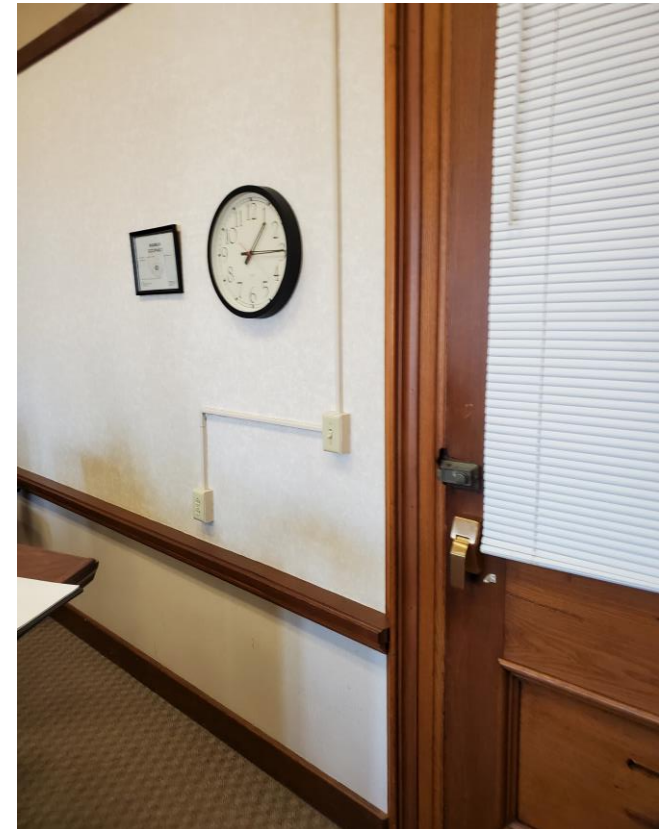
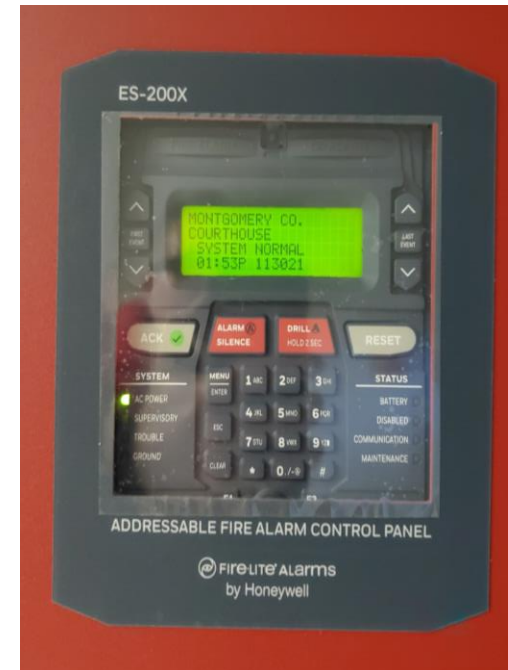
- All Light fixtures replaced around 2010 by guaranteed energy savings completed by Amersco
- Recommend changing Light fixtures from fluorescent to LED
- Lighting controls are all manual
 - Recommend replacing with automatic controls
- Replace exit lights
- No reported issues with building Fire Alarm System
- Fire Alarm Control Panel replaced around 2020
- Vendor owned WiFi
- Building current uses Plain old telephone system copper lines
 - Staff reported the building will be switching over to PPX/Voice over IP (VOIP) system

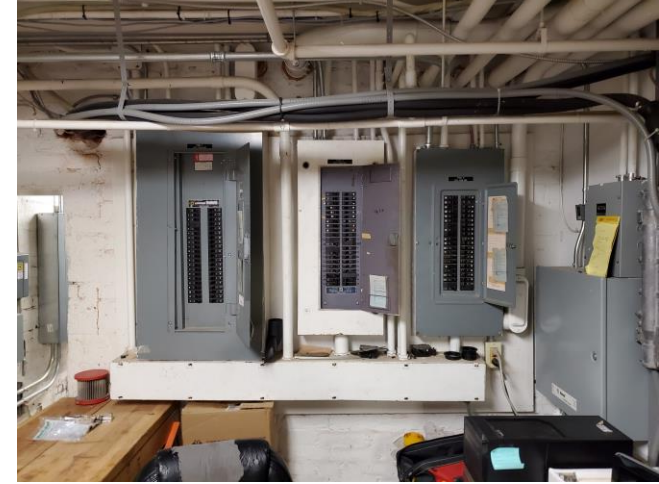
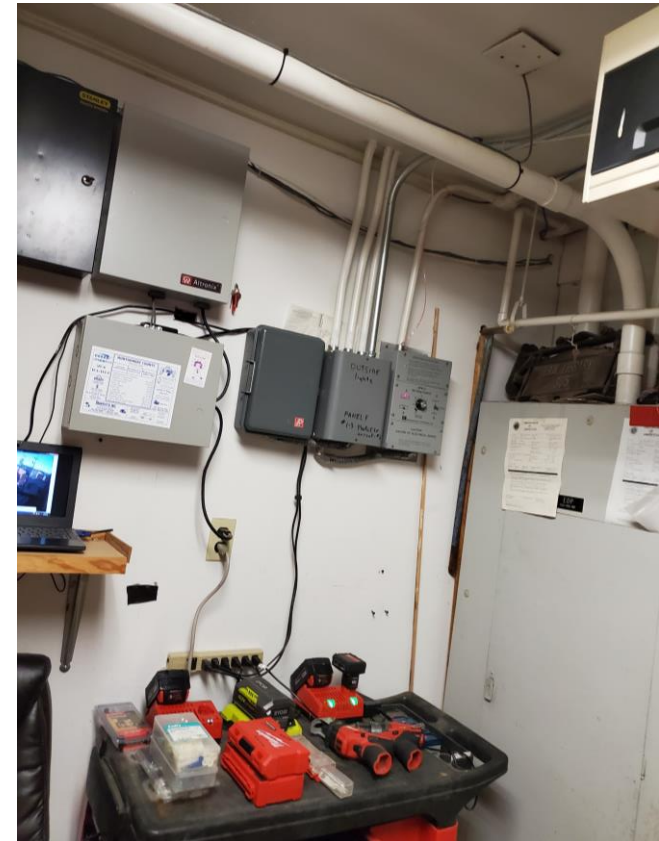
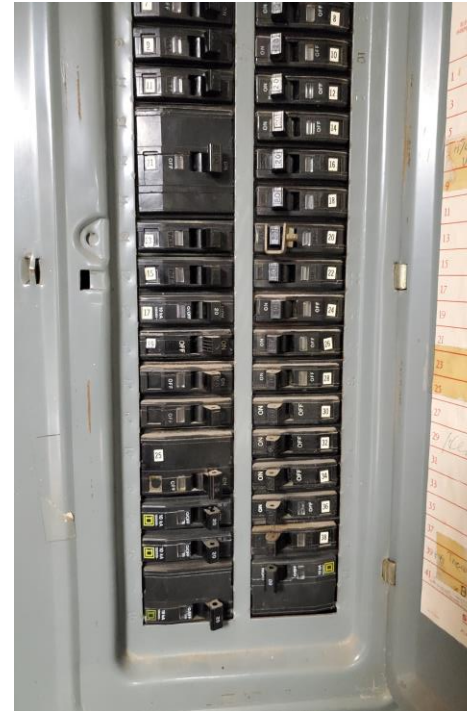
- Staff reported electrical panels are full, with minimal spare circuits available
- Staff reported Fan Coil Units share branch circuitry. Circuit overcurrent protection has been modified to 30A to prevent nuisance tripping.
 - NOTE: Violation of NFPA 70-2008 (National Electrical Code) article 240.4D(5)
 - Recommend re-circuiting Fan Coil Units to allow branch circuit conductors to be properly protected
- Building does not have a Generator
- Building has two different access control systems: Stanley (old) and SAS (newer)
- Staff reported Stanley system head-end currently resides on a Windows XP system
- Recommend converting building to newer (SAS) system
